Preservation Strategies: Three Examples

PRESERVATION: LONG BEACH ISLAND MUSEUM 129 ENGLESIDE AVENUE

REHABILITATION: DR. WILLIAMS HOUSE "ONION DOME" 502 S. ATLANTIC AVENUE

RESTORATION: NEW SECOND STORY WINDOWS 114 SECOND STREET

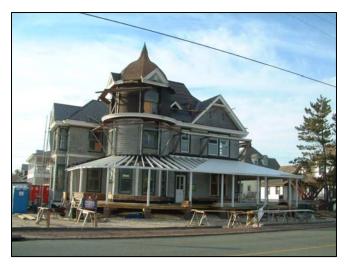
During rehabilitation in 2006

Rehabilitation efforts have included changing the floor plan to create guest rooms and an apartment for caretaker. The most deteriorated windows were replaced with windows that have an appropriate Queen Anne style configuration. Several synthetic materials, one that mimics the appearance of wood and the other of slate, have been used on the trim and roof, respectively.

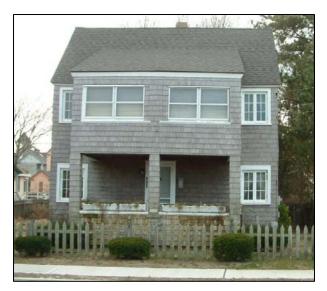
114 Second Street in 2006

With the installation of new, "old fashioned," wood frame, divided light, casement windows on the second story enclosed porch, this charming shingled house could be restored to an earlier time when the sleeping porch was first enclosed. This would constitute a more historic appearance. The photograph of

the house's appearance in 2006 (on the left) was doctored using a computer paint program (on the right) to show that even with a small appropriate project, the house's historic character can be increased considerably.
